4. TITLE (and Subtitle) MANUFACTURING METHODS AND TECHNOLOGY PROGRAM FOR THE 10-kHz TAPE-AUTOMATED BONDED HYBRID MICROCIRCUIT OSCILLATOR FINAL REPORT		5. TYPE OF REPORT & PERIOD COVERED Final report

7. AUTHOR(s) Bernard E. Goblish		6. PERFORMING ORG. REPORT NUMBER 2730-41637
9. PERFORMING ORGANIZATION NAME AND ADDRESS Honeywell Inc. Defense Systems Division Hopkins, MN 55343		8. CONTRACT OR GRANT NUMBER(s) DAAG39-78-C-0010 PRON:8183663703GGA9

20. ABSTRACT (Continue on reverse side if necessary and identify by block number) A Manufacturing Methods and Technology (MM&T) program was conducted on a 10-kHz hybrid microcircuit oscillator for use in electronic time fuzes. The oscillator which was originally developed under contract DAAG39-77-C-0056, uses tape-automated bonding (TAB) techniques to eliminate the use of individually bonded wires. The processes and achievable production rates were investigated and a total of approximately 2000 circuits were

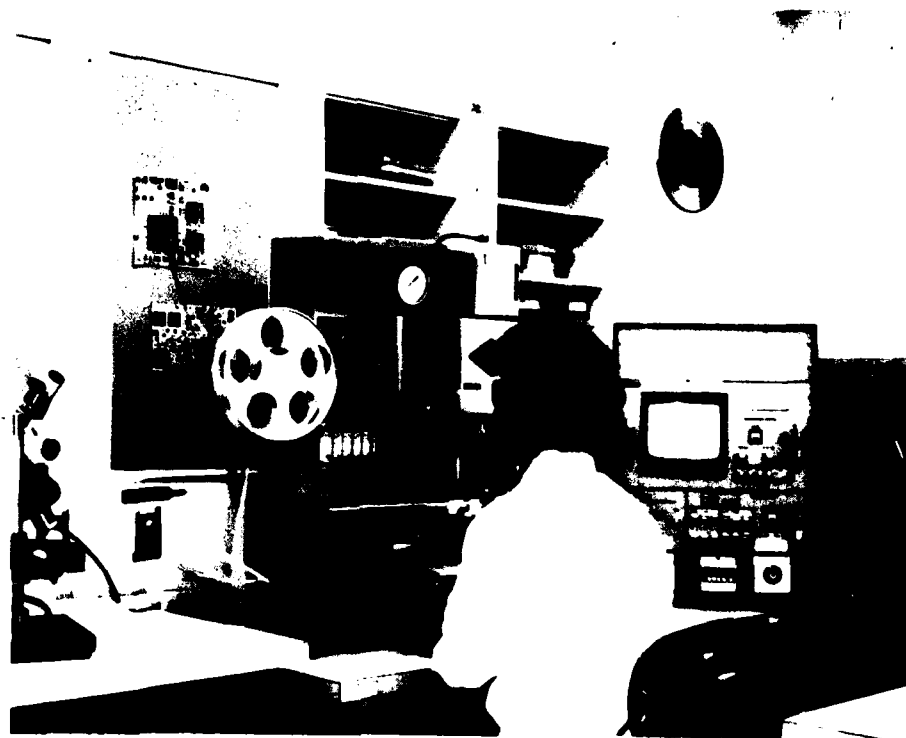
Figure 45. Auto Roll screen printer.

An Auto Roll screen printer shown in fig. 45, was used for the solder screen printing process. The substrates were placed on the stage and removed manually. A screen printing rate of 632 devices per hour was achieved.

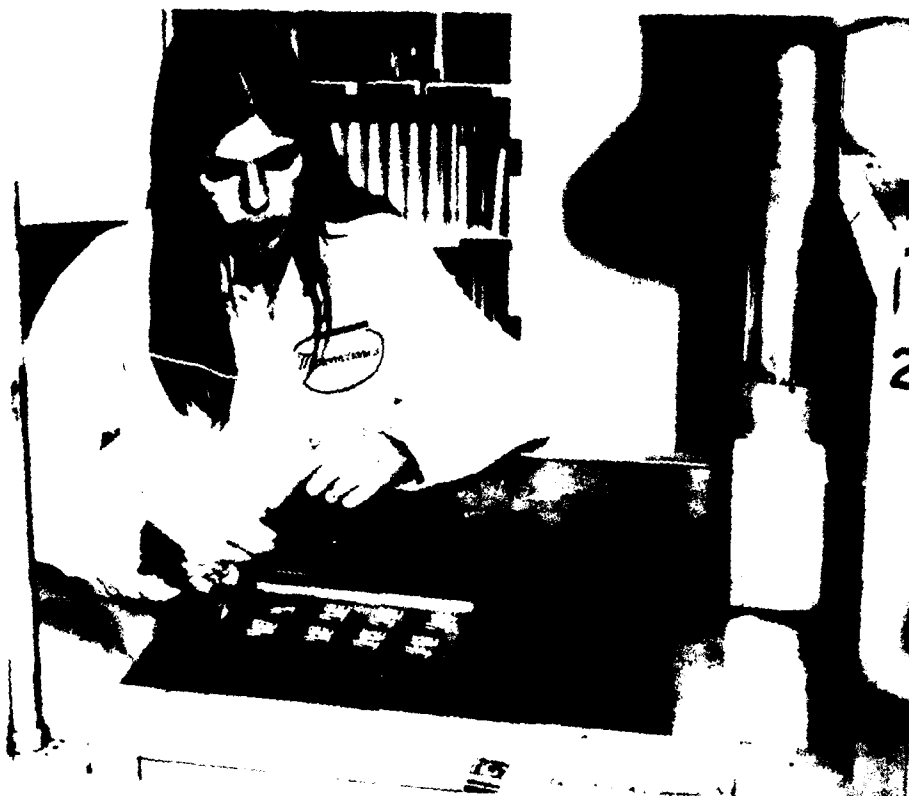
Figure 47. Watkins Johnson reflow furnace.

A Watkins Johnson reflow furnace (fig. 47) was used for the solder reflow process. The solder reflow process was

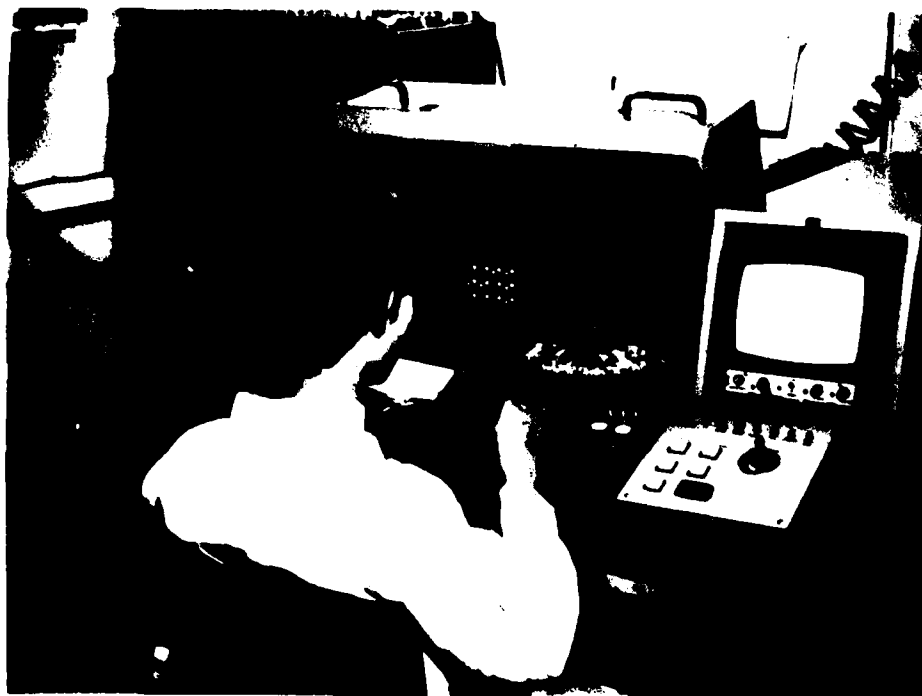
Figure 48. ESI model 25 laser system.

An ESI Model 25 laser system was used for laser trimming the TAB HMO. This system is shown in fig. 48. Laser trimming was performed using the associated circuit shown in fig. 49. The voltage follower buffers the amplifier output to eliminate loading effects. The relay is used to turn the voltage source off after each laser bite. It is necessary to turn the voltage source off as noise induced from the laser trimming creates erroneous voltage measurements which enhance overtrimming.
